Stencil Pavement Repair

Technical Bulletin 0105

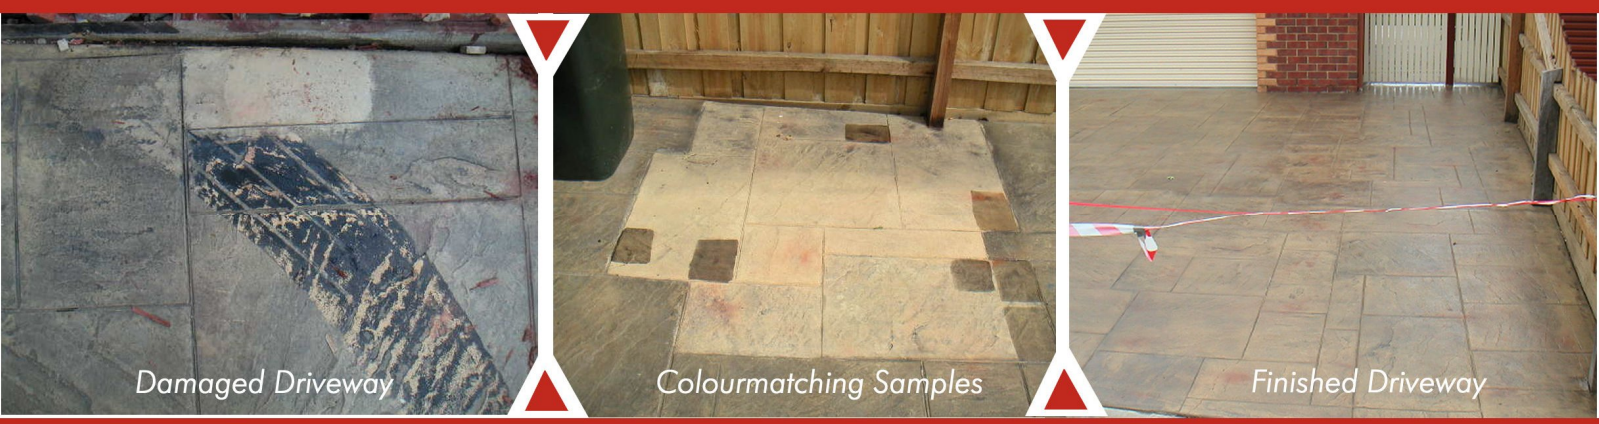
The first picture on the left displays the damaged slatecrete stamped concrete driveway. As a result of a motor vehicle accident, rubber burn marks had been burnished into the top coating system causing the colour to be removed back to the base concrete underneath.

As seen in the centre picture, the driveway topcoats and rubber tyre marks were removed using the Graffiti Eaters surface restoration technology and the surface thoroughly prepared for recoating.

Using a blend of releasing agents and pigments, a coating system was then devised to colourmatch the slatecrete effect, and repair the driveway. The shadowing highlights and translucency of this particular colour made it a challenging match to achieve.

The end result was a perfect repair that blended in with the backyard, tyre mark free, at a fraction of the cost of ripping up and relaying a new driveway, saving this insurance company significant costs.
